TECHNICAL SERVICE BULLETIN

Number: TSB-FC-2015-039

Symptom: Brush not rotating

Nilfisk SC100

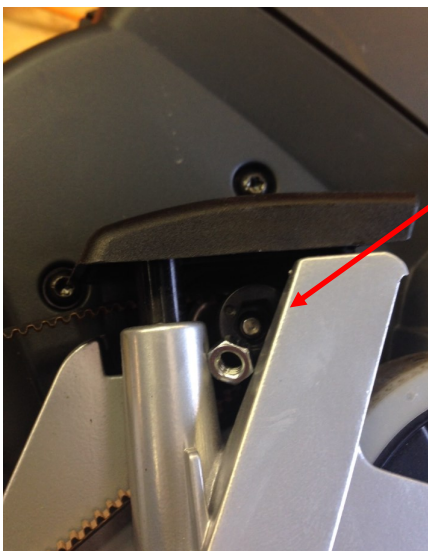
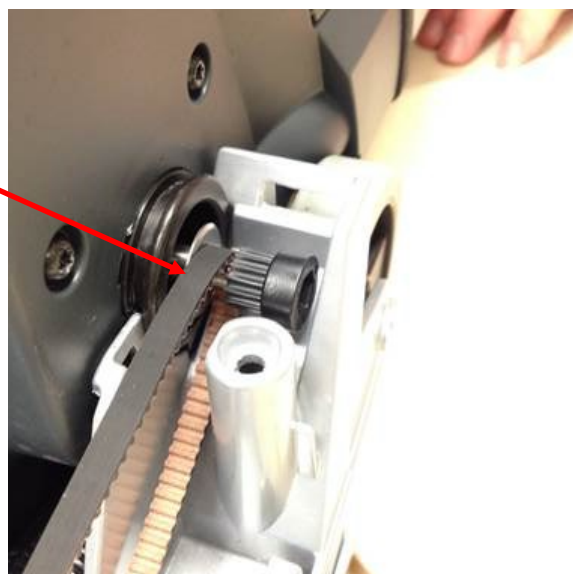
COMPONENT LOCATIONS / PICTURES:

The nut at the end of the motor shaft has fallen off.

Nut is only locked by screw itself, vibration or shake can make nut loose, in this situation, without power and push machine forward, Cog wheel will be affected by a reaction from motor shaft, this can cause nut and cog wheel fall off.

Add Loctite 243 threadlocker (blue) between motor shaft and nut .
